In re Flint Water Cases,
No. 16-cv-1044

Supplemental Report of Dr. Larry L. Russell

October 18, 2022

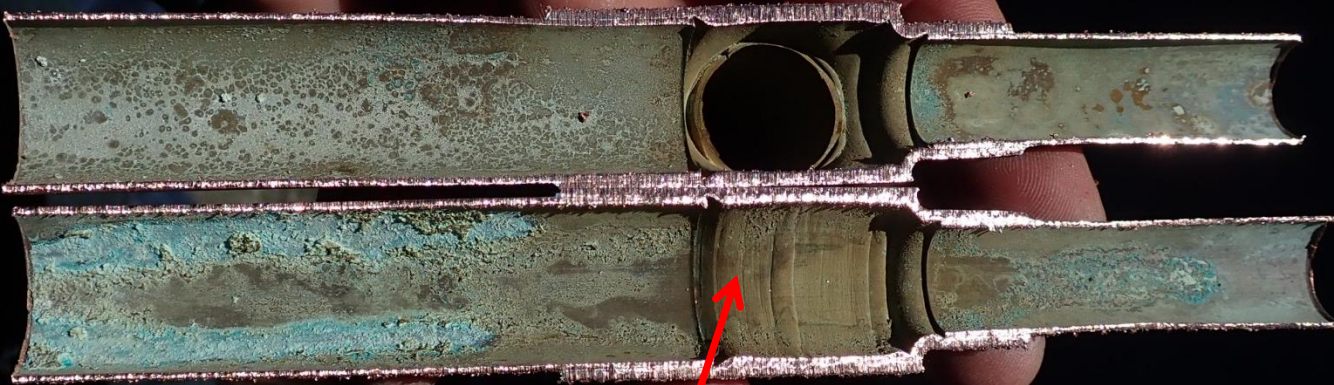
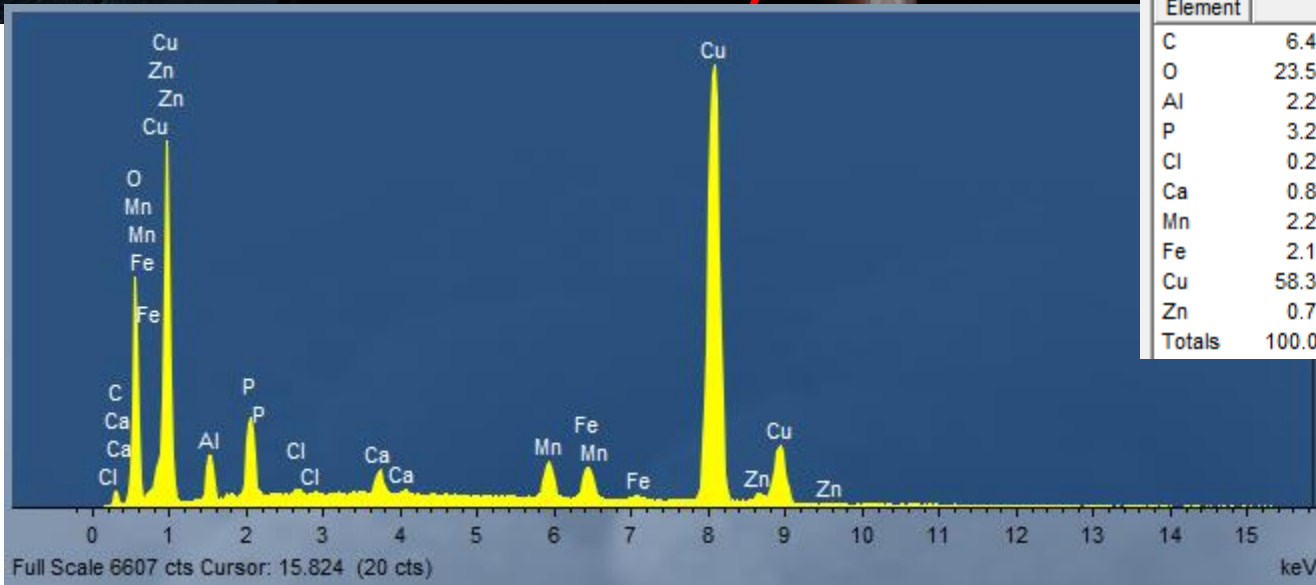
Flint A - Scale at Fitting

Element	Weight%
C	6.44 +/- 0.53
O	23.53 +/- 0.36
Al	2.20 +/- 0.09
P	3.29 +/- 0.10
Cl	0.25 +/- 0.05
Ca	0.83 +/- 0.05
Mn	2.20 +/- 0.09
Fe	2.10 +/- 0.09
Cu	58.38 +/- 0.46
Zn	0.77 +/- 0.15
Totals	100.00

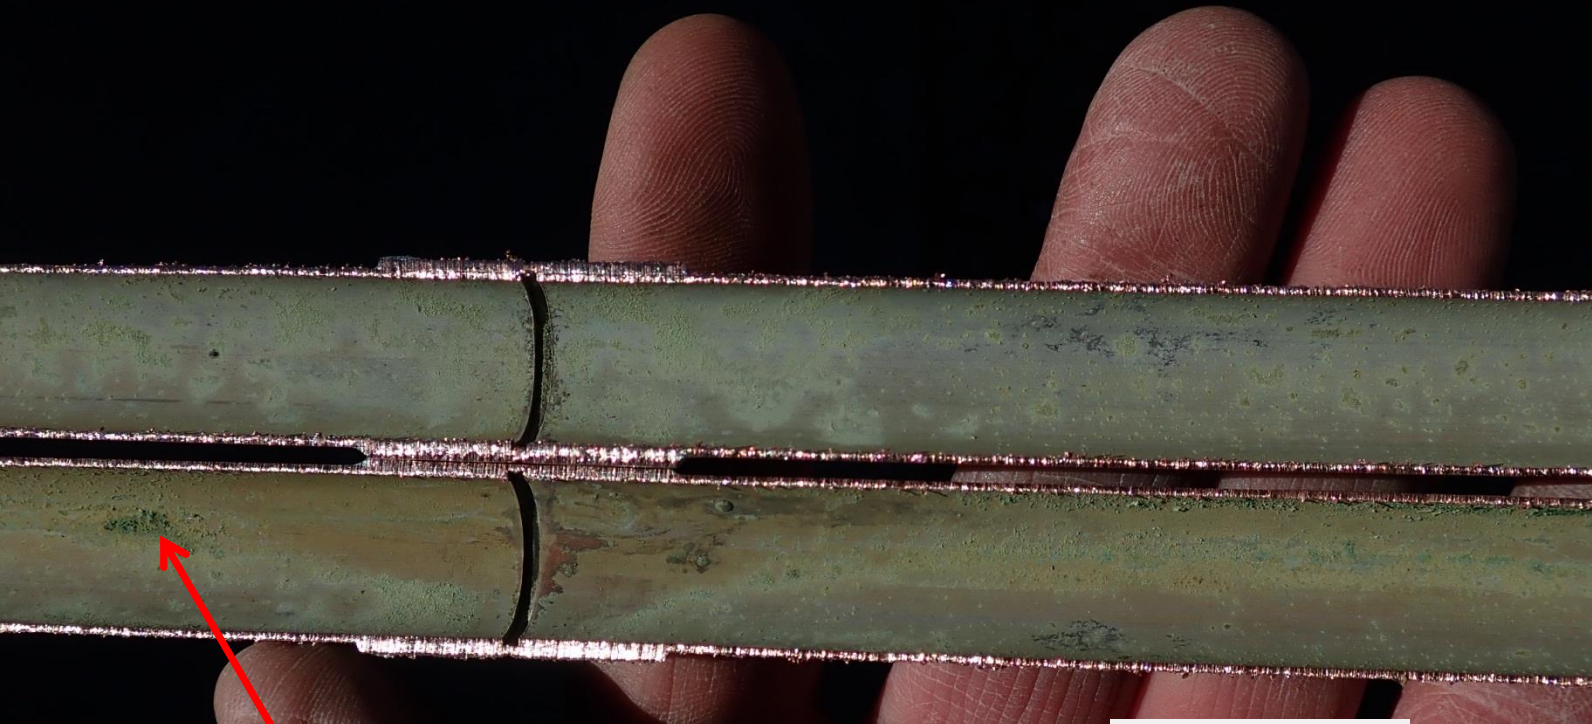
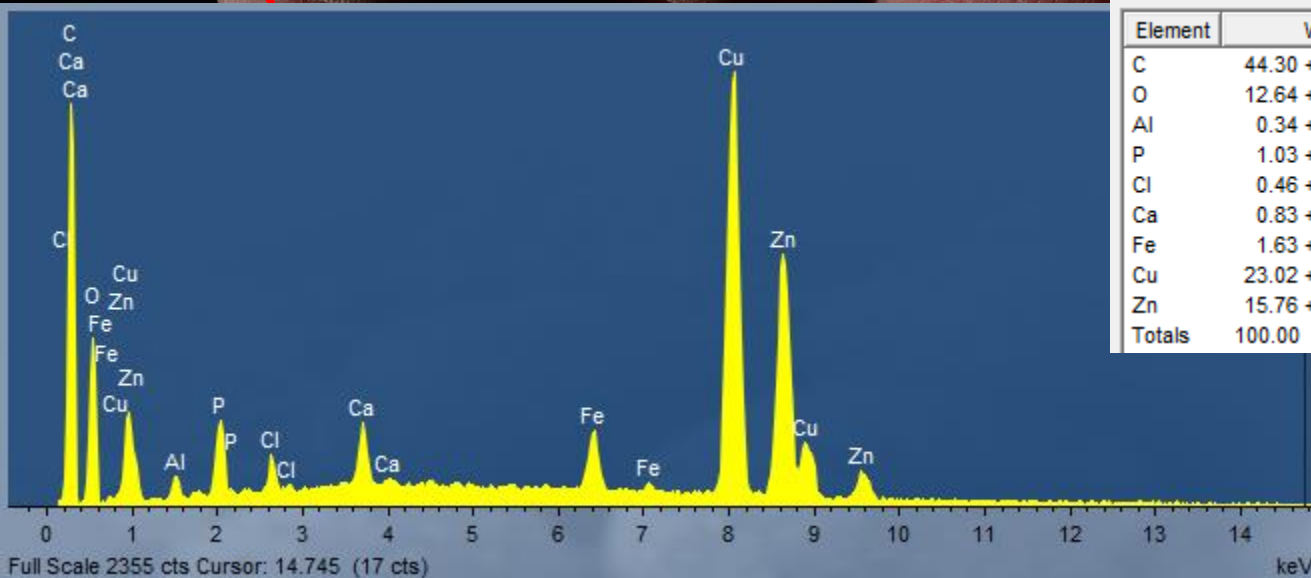
Flint B

Element	Weight%
C	44.30 +/- 0.59
O	12.64 +/- 0.38
Al	0.34 +/- 0.04
P	1.03 +/- 0.06
Cl	0.46 +/- 0.04
Ca	0.83 +/- 0.05
Fe	1.63 +/- 0.08
Cu	23.02 +/- 0.34
Zn	15.76 +/- 0.30
Totals	100.00

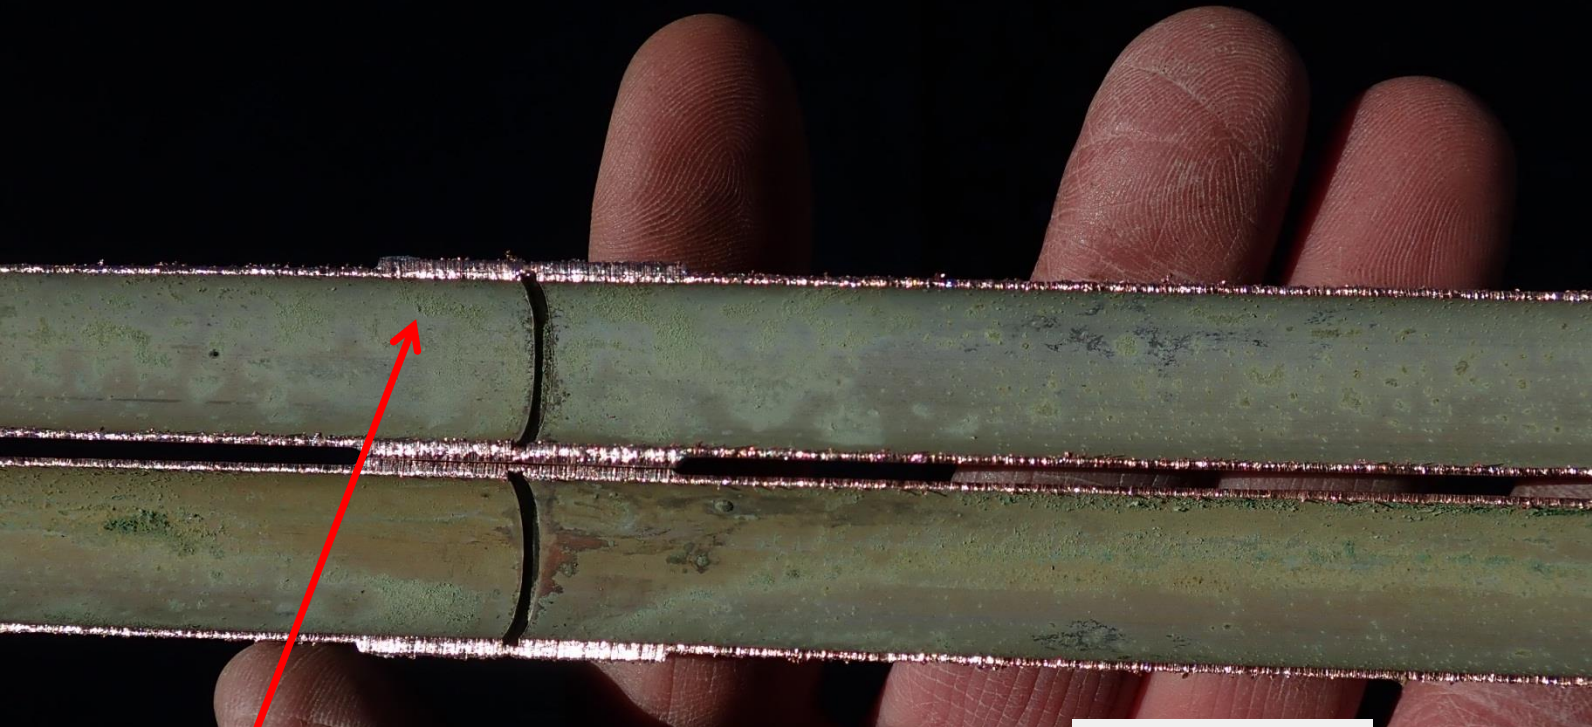
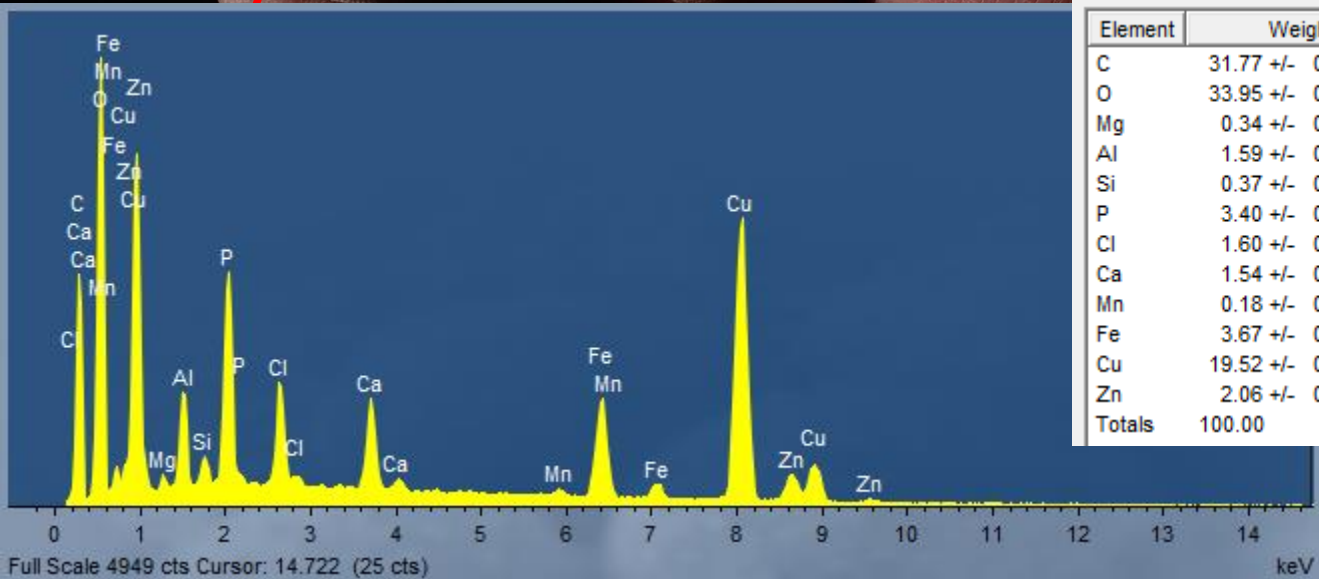
Flint B

Element	Weight%
C	31.77 +/- 0.50
O	33.95 +/- 0.41
Mg	0.34 +/- 0.05
Al	1.59 +/- 0.06
Si	0.37 +/- 0.04
P	3.40 +/- 0.07
Cl	1.60 +/- 0.05
Ca	1.54 +/- 0.05
Mn	0.18 +/- 0.04
Fe	3.67 +/- 0.08
Cu	19.52 +/- 0.24
Zn	2.06 +/- 0.11
Totals	100.00

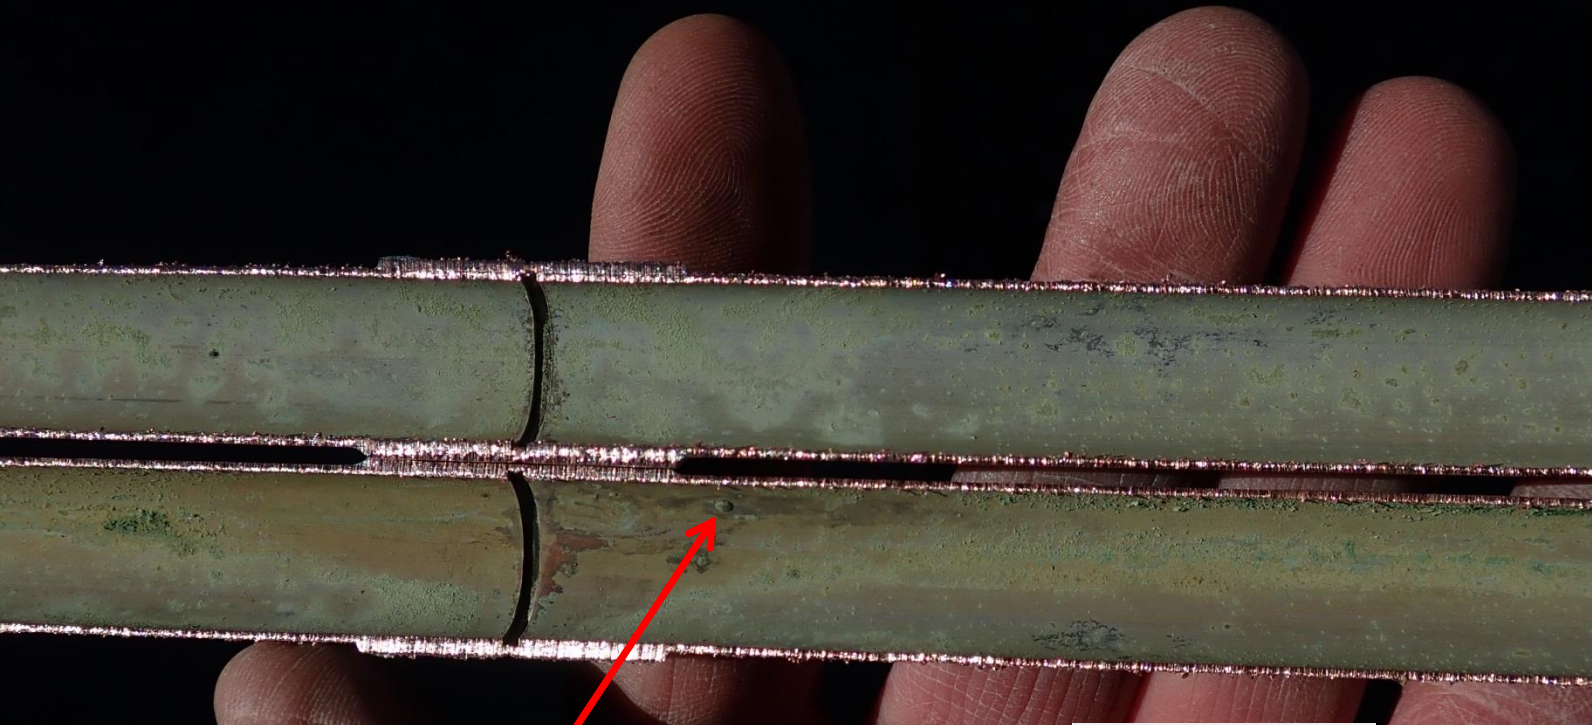
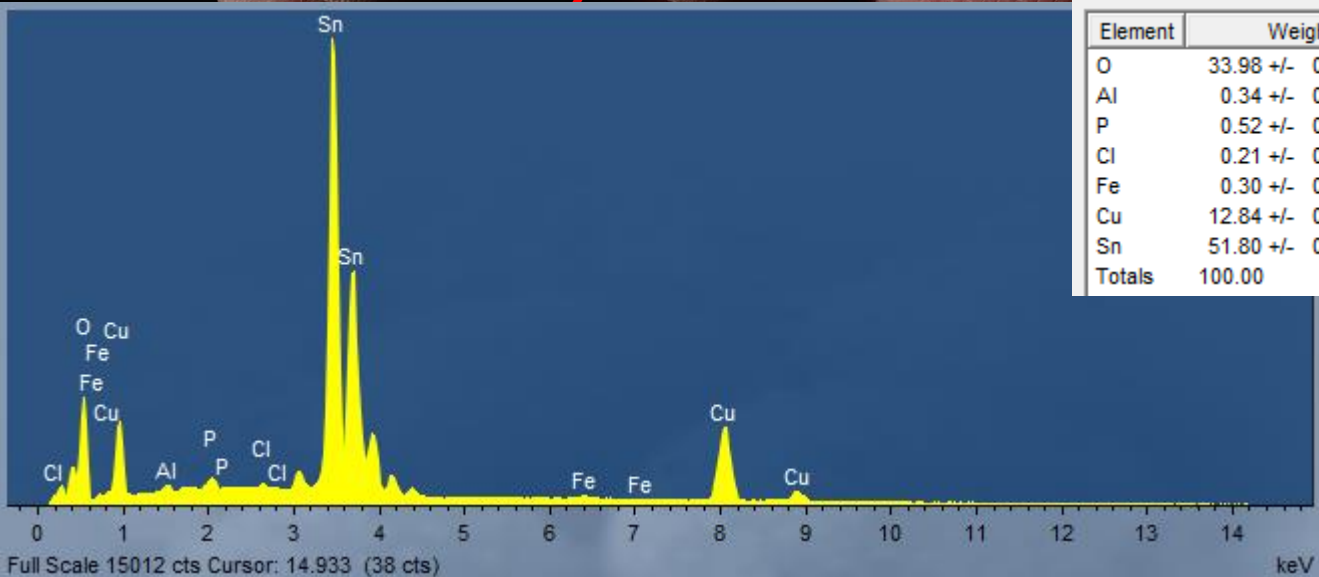
Flint B

Element	Weight%
O	33.98 +/- 0.46
Al	0.34 +/- 0.05
P	0.52 +/- 0.05
Cl	0.21 +/- 0.04
Fe	0.30 +/- 0.06
Cu	12.84 +/- 0.17
Sn	51.80 +/- 0.38
Totals	100.00

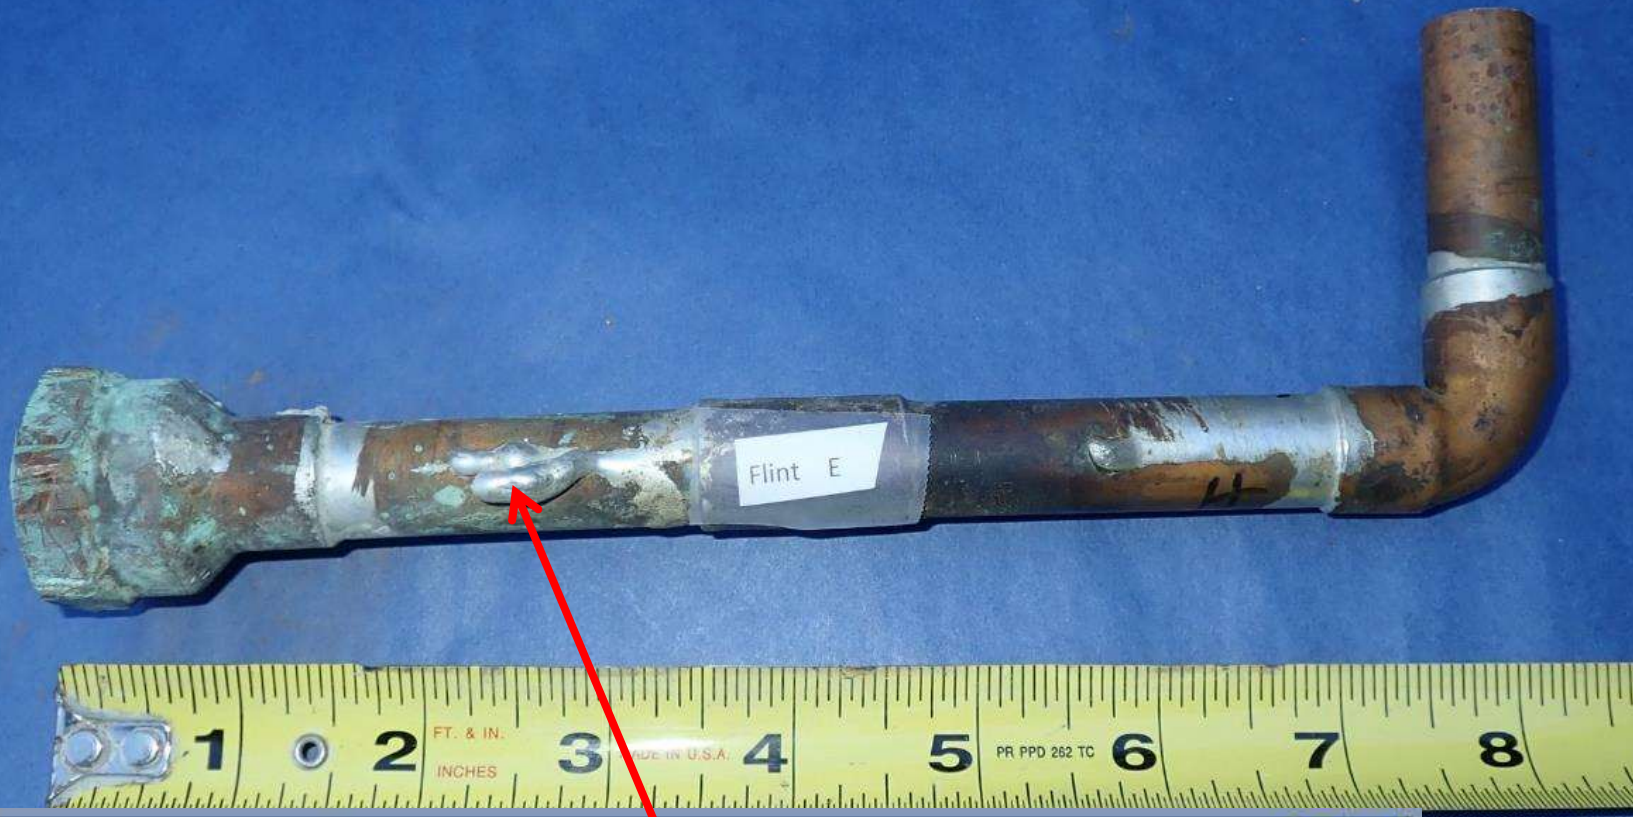
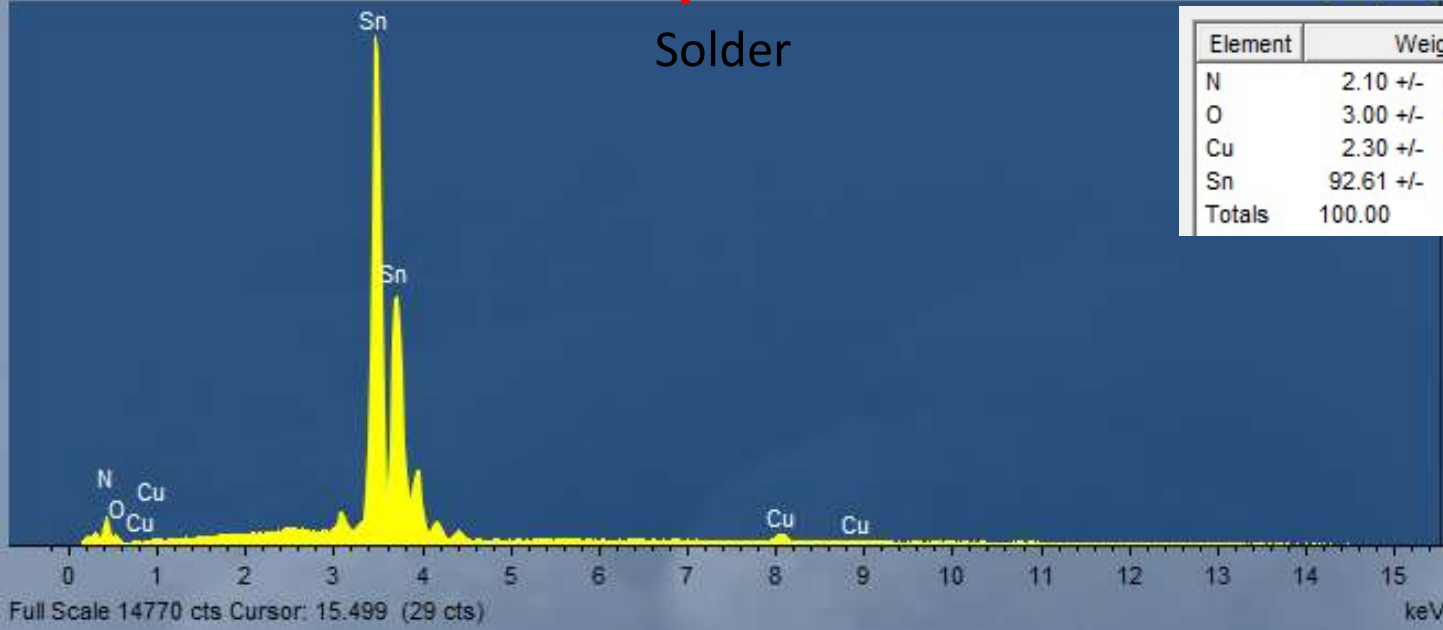
Flint E

Solder

Element	Weight%
N	2.10 +/- 0.76
O	3.00 +/- 0.77
Cu	2.30 +/- 0.15
Sn	92.61 +/- 1.04
Totals	100.00

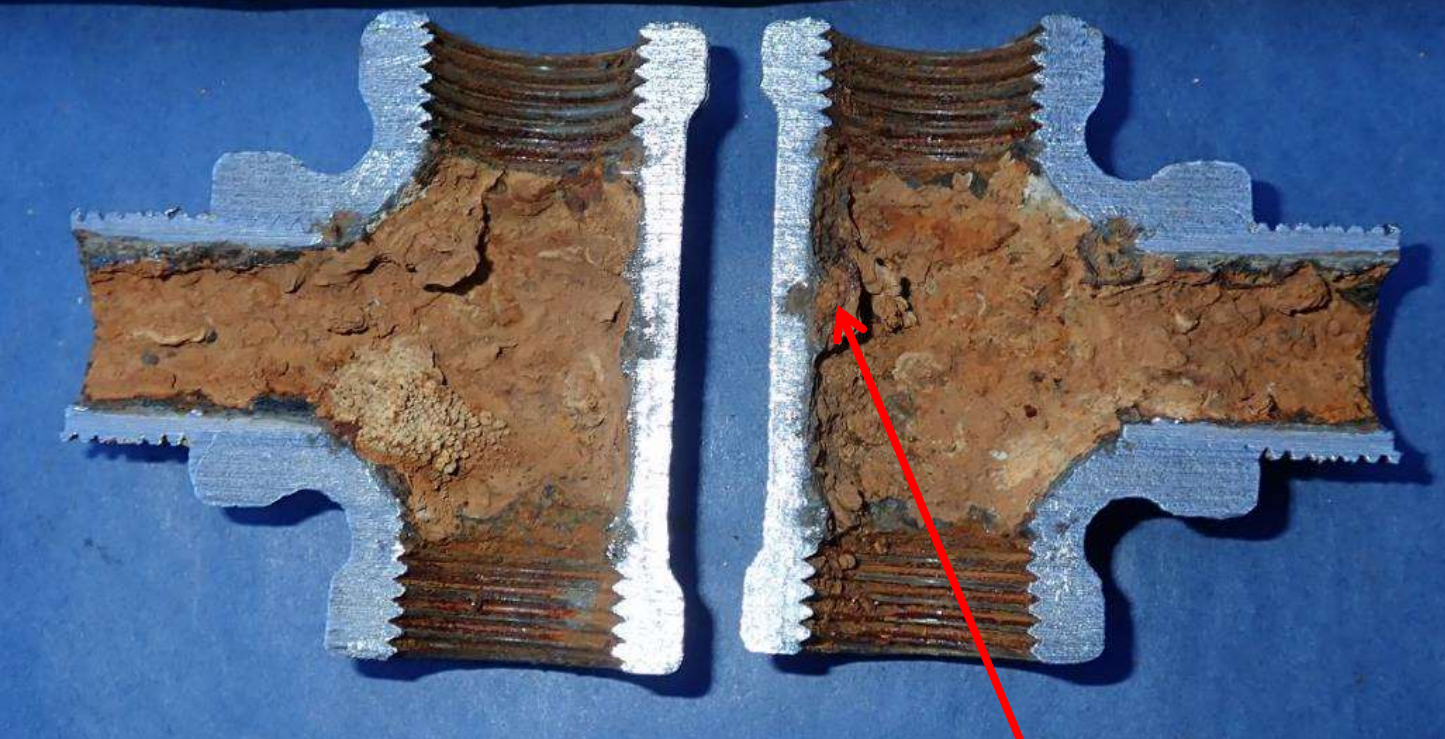
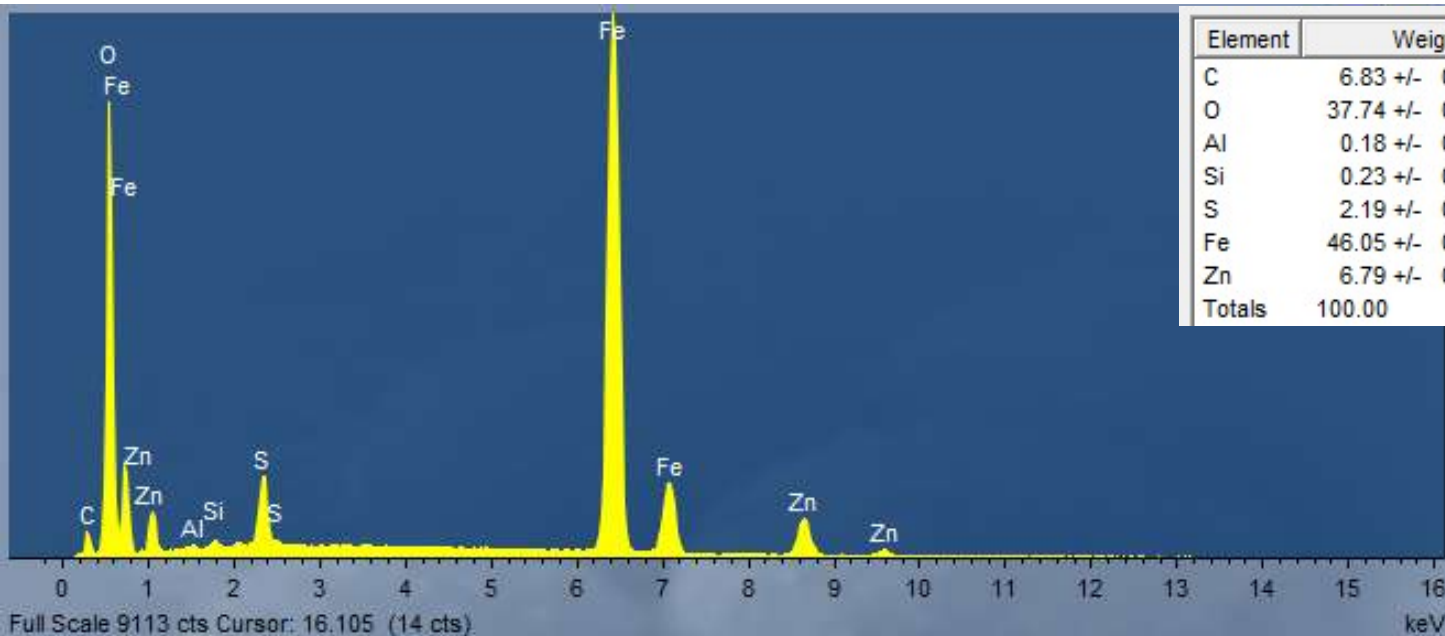
Flint G

Element	Weight%
C	6.83 +/- 0.40
O	37.74 +/- 0.32
Al	0.18 +/- 0.05
Si	0.23 +/- 0.05
S	2.19 +/- 0.06
Fe	46.05 +/- 0.32
Zn	6.79 +/- 0.17
Totals	100.00

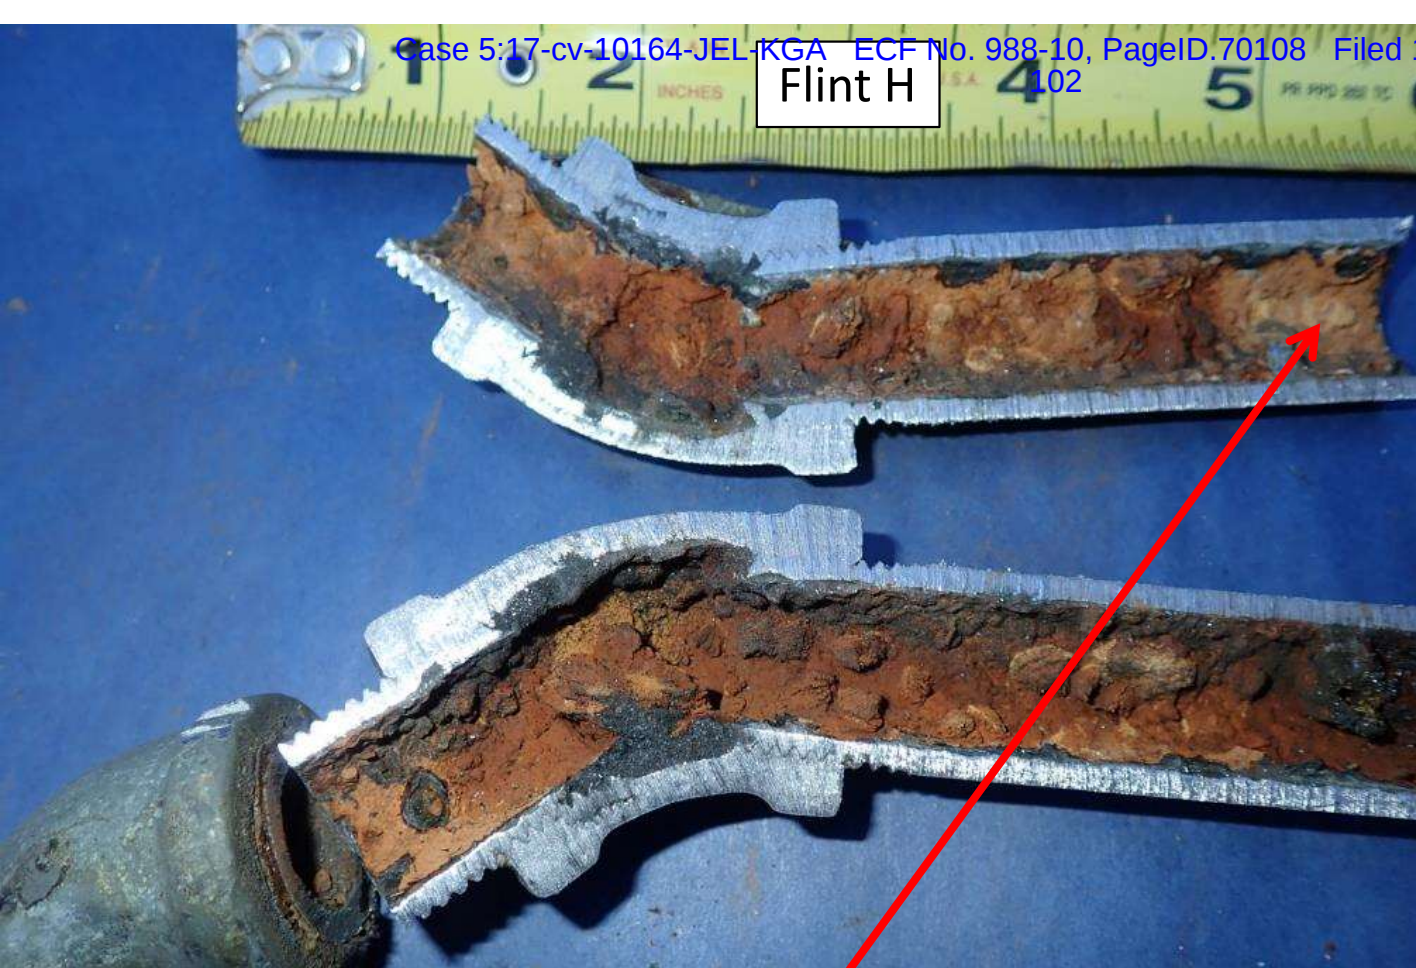
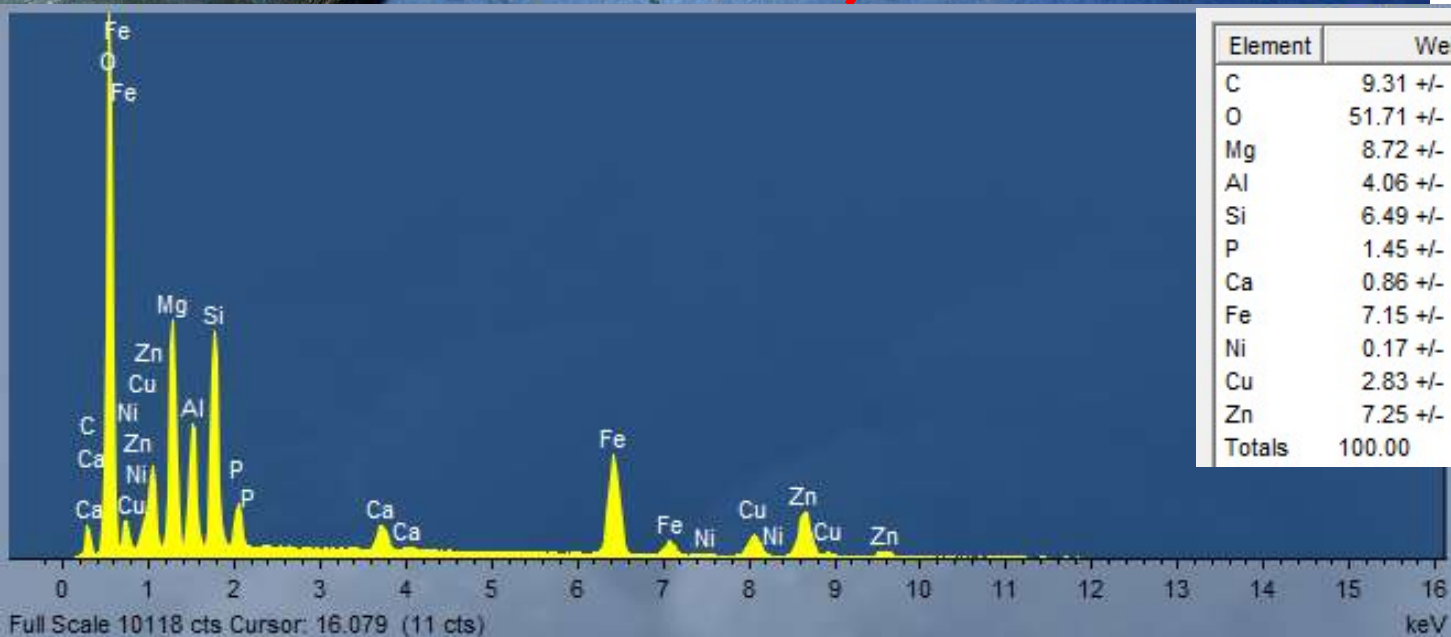
Flint H

Element	Weight%
C	9.31 +/- 0.43
O	51.71 +/- 0.36
Mg	8.72 +/- 0.13
Al	4.06 +/- 0.08
Si	6.49 +/- 0.10
P	1.45 +/- 0.06
Ca	0.86 +/- 0.04
Fe	7.15 +/- 0.11
Ni	0.17 +/- 0.05
Cu	2.83 +/- 0.10
Zn	7.25 +/- 0.15
Totals	100.00
